The impact of selected parameters on the fatigue strength of splices on multi-ply textile conveyor belts

Ryszard BŁAŻEJ
Mirosław BAJDA
Monika HARDYGÓRA

Laboratory of Belt Transportation

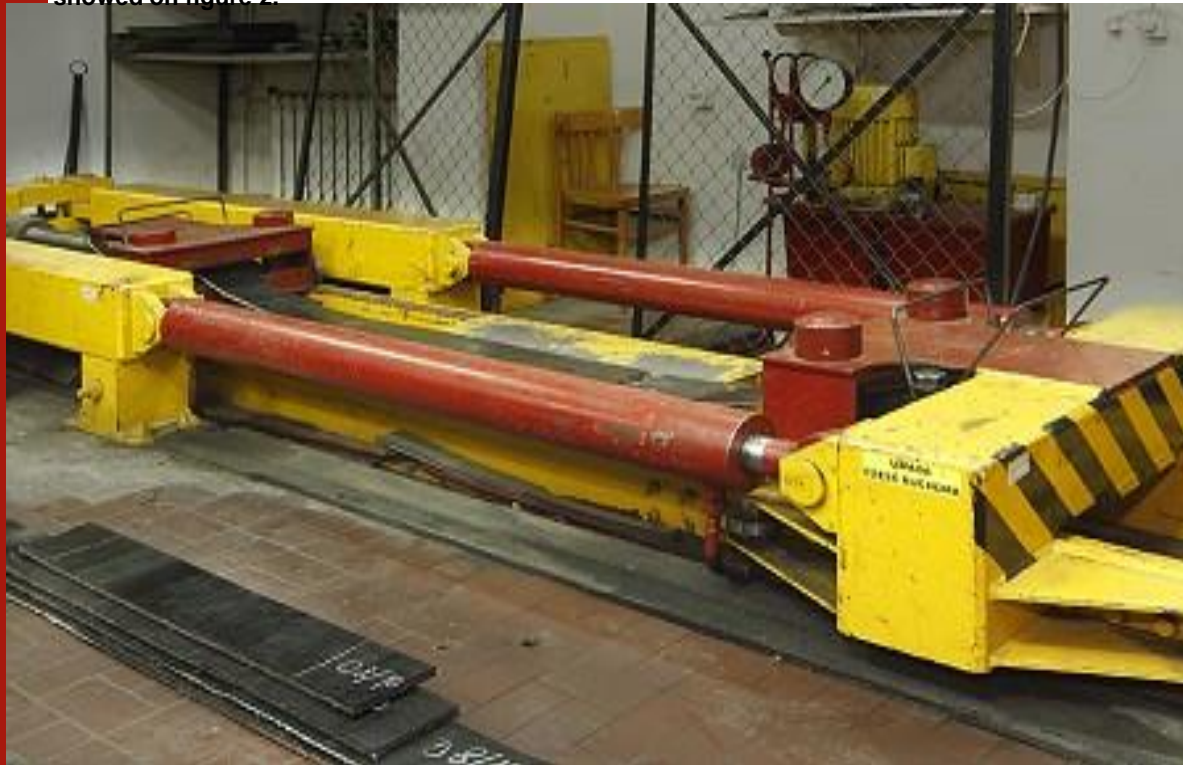
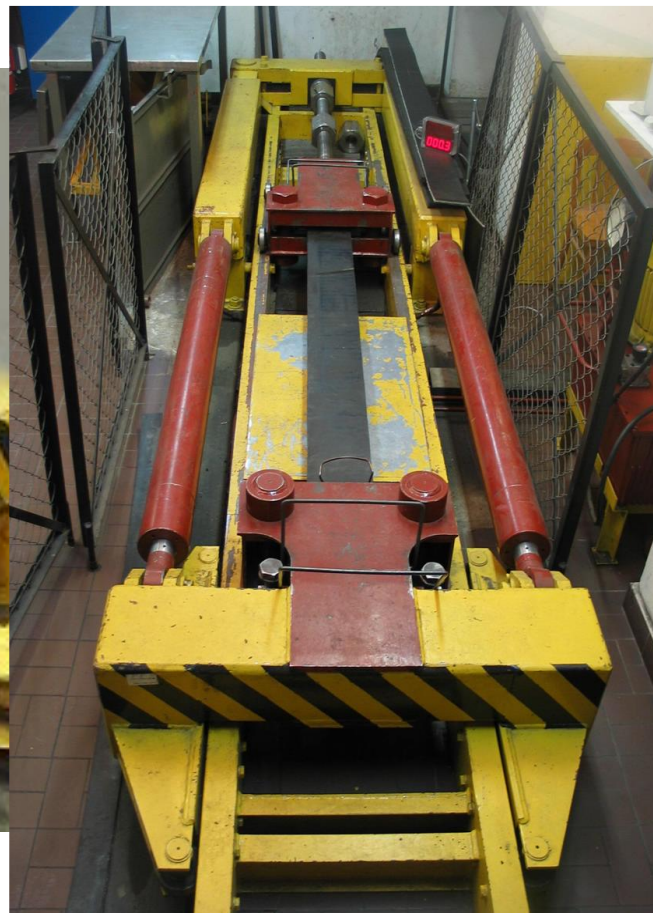
Fig. 1

Method of evaluating the tensile strength of joints ZP-40 tensile testing machine for belt's joints

The extension strength of joints was determined using the samples which were 200 mm wide while their length was equal to the total length of the joint plus the handle parts according to the PN-C-94147:1997 standard requirements [2]. Tests were carried out on joints ripper specially designed for such tests (Fig 1). Tested joints were of different structure what is schematically showed on figure 2.

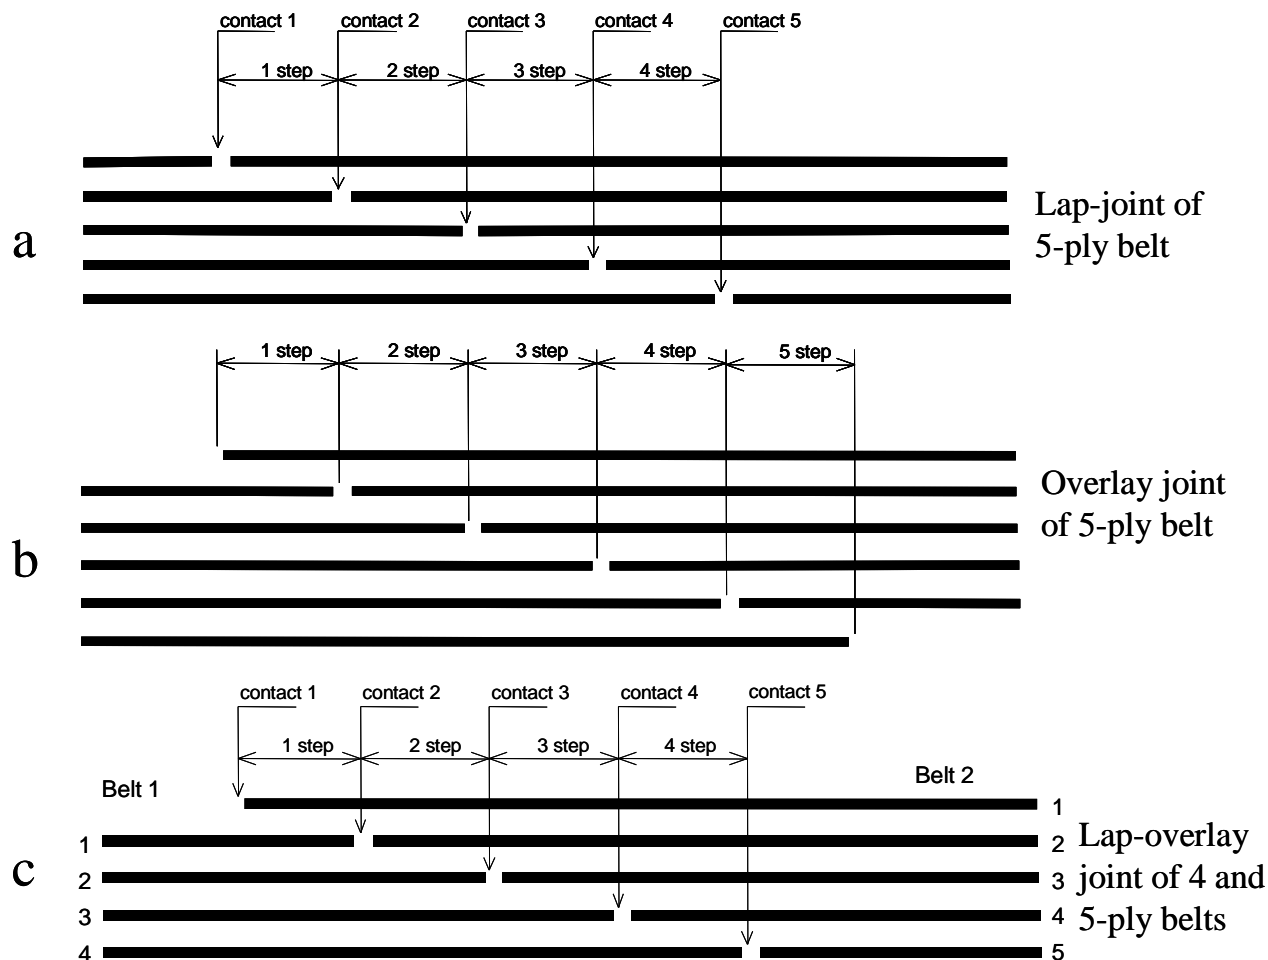
Fig. 2

Schematic layout of joints

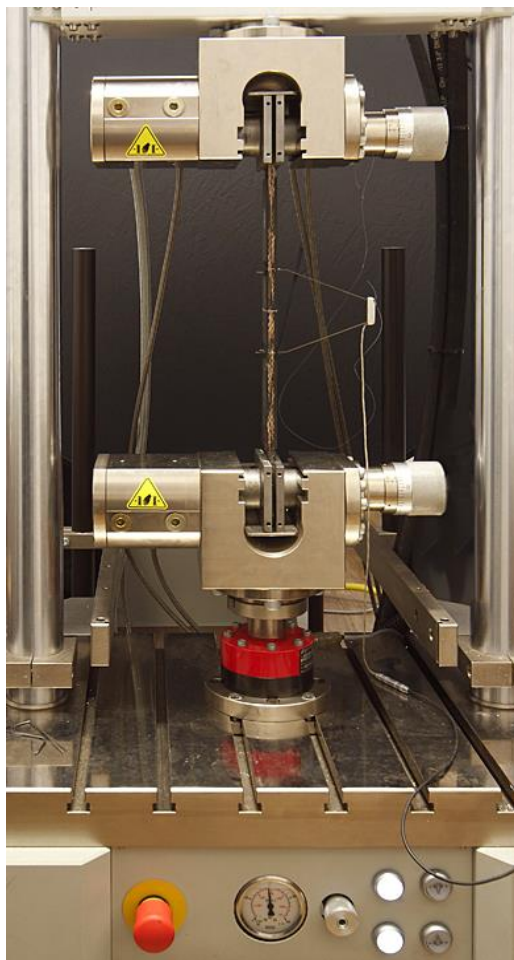
Fig.3. Dynamic machine ZD-25 Zwick/Roell

Dynamic tests of conveyor belt connections

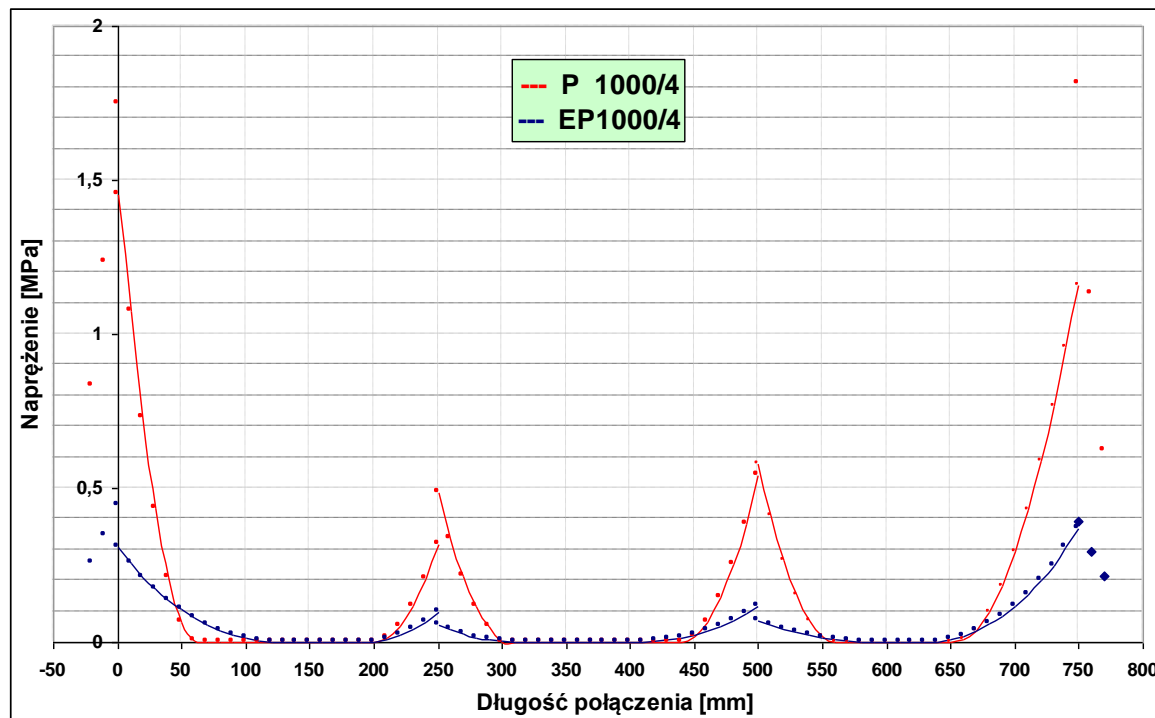
Fig.4. Distribution of shear stresses in adhesive-bonded joint of belt EP 1000/4 and P 1000/4 connection loaded by the force equal 15% of belt strength

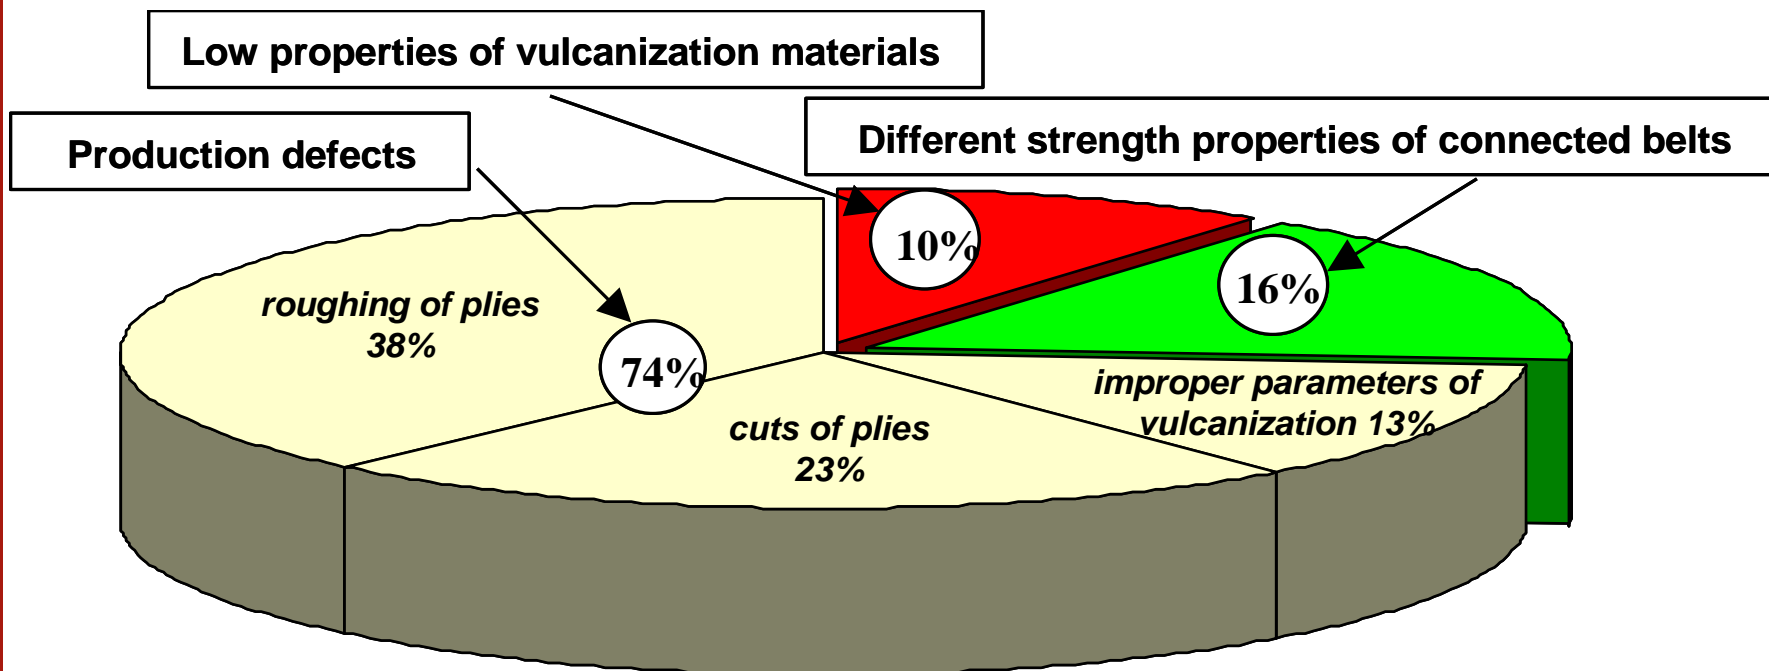
Fig. 6

Some 60 joints, which strength was lower than expected, were selected for the analysis, from all joints tested during last several years. The percentage of individual reasons of reduced strength of joints is presented on figure 6.

Among the production defects are roughing of plies, cuts of plies or improper parameters of vulcanization. Roughing of plies destroyed the structure of plies what in turn reduced their strength. This defect occurs most often during removing the friction rubber from ply. Cuts of plies arising during benching the joints, generally occur at the connections of joints and therefore they increase the accumulation of stresses occurring there. Those defects reduced the joints strength by about 30%. Improper parameters of vulcanization are mostly insufficient pressure of vulcanization resulting in rubber porosity or improper temperature of vulcanization.

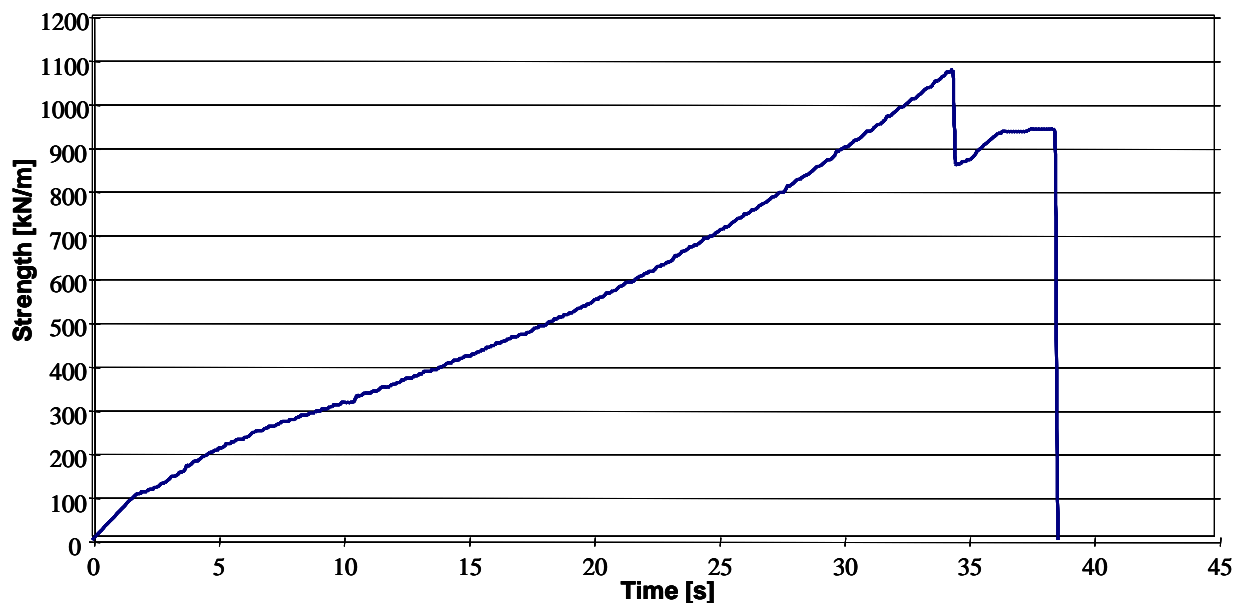
Example of the first type is a joint of a EP type belt with a polyamide belt. While testing the tensile strength of such joint it was found that failure of joint occurs in two stages; first the plies of EP belt are broken and afterwards of the polyamide one. Example diagram of tensioning such joint is presented on figure 7. The similar pattern of failure have the joints of the second type. Average strength of such joints reaches about 65 % of required value.

Fig. 7. Diagram of tensioning the joint of polyester and polyamide belts
